FIRE AND MATERIALS 2005

LIGHTNING INDUCED CSST FIRES

Mark Goodson PE*
Mark Hergenrether MSME*
Goodson Engineering, USA

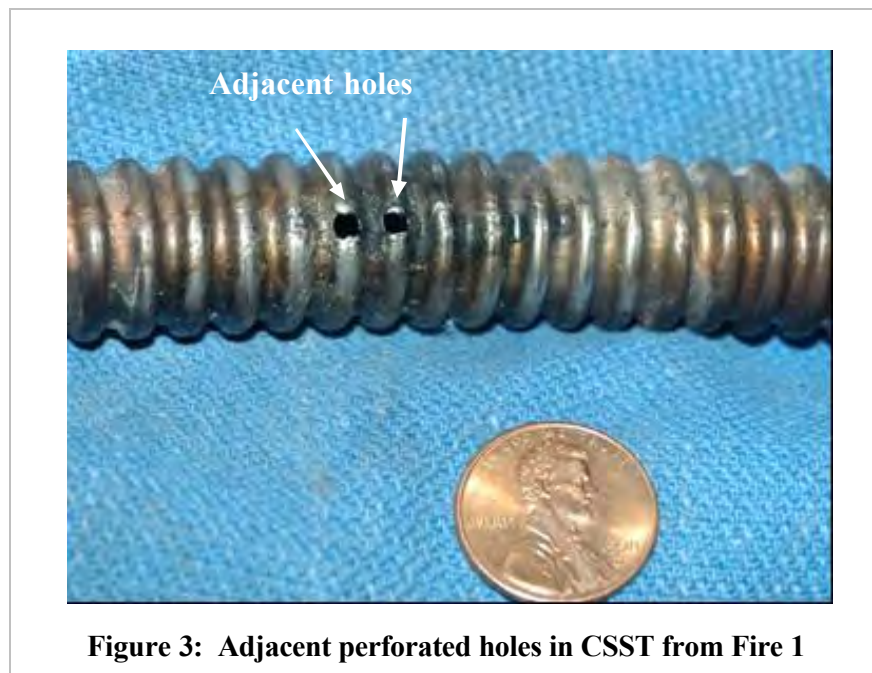
The fire occurred in the wood framed chimney space that had a metal chimney insert. CSST ran through the chimney space to feed the gas igniter. Four perforations were found in the CSST, ranging in size from a pinhole to a hole about 125 mils along its major axis. A STRIKE FAX lightning report showed that 4 hits within 0.1 mile of the house were recorded¹¹. Figure 3 shows 2 adjacent holes that were created in the CSST.

Figure 3: Adjacent perforated holes in CSST from Fire 1

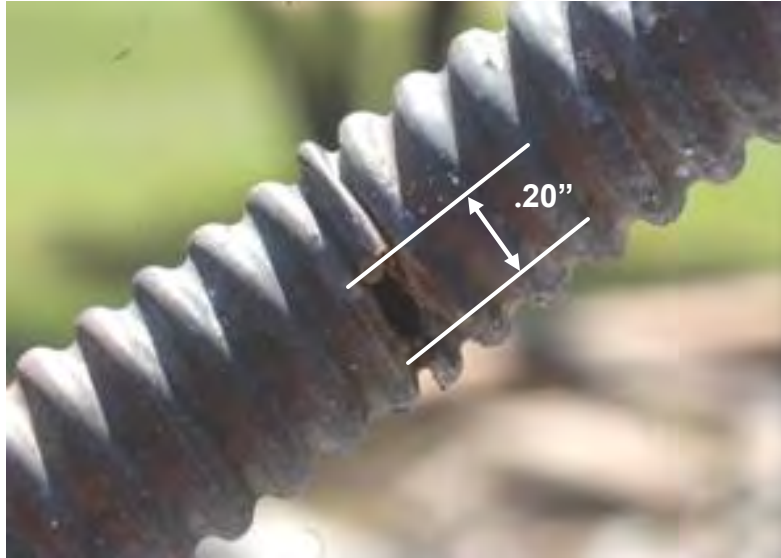
The fire occurred in an expensive house (construction not finished) with a value in excess of 6 figures. The house was a 2 story house, and plumbed with approximately 95% black pipe. Two runs of CSST, each serving a fireplace, comprised the CSST piping in the house. A perforation with its major axis measuring approximately 200 mils was found in one run of the CSST (Figure 4). An interview with a neighbor confirmed that the audible and visual components of the strike were sensed simultaneously. A positive lightning report was obtained, showing 11 strikes within 0.5 mile. Regrettably, the house was razed before the investigation was complete. Figure 5 shows the failed CSST run to the fireplace.

Figure 4: Perforated CSST pipe from Fire 2

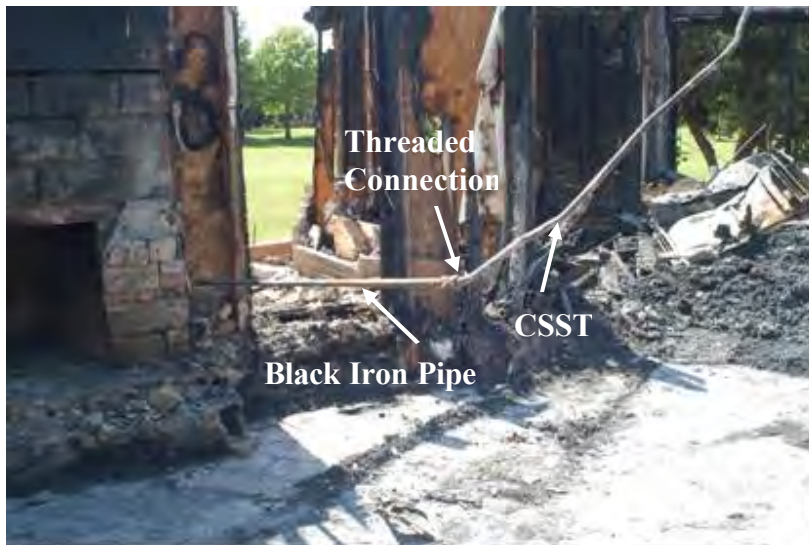
Figure 5: CSST tied to Black Iron pipe from fireplace

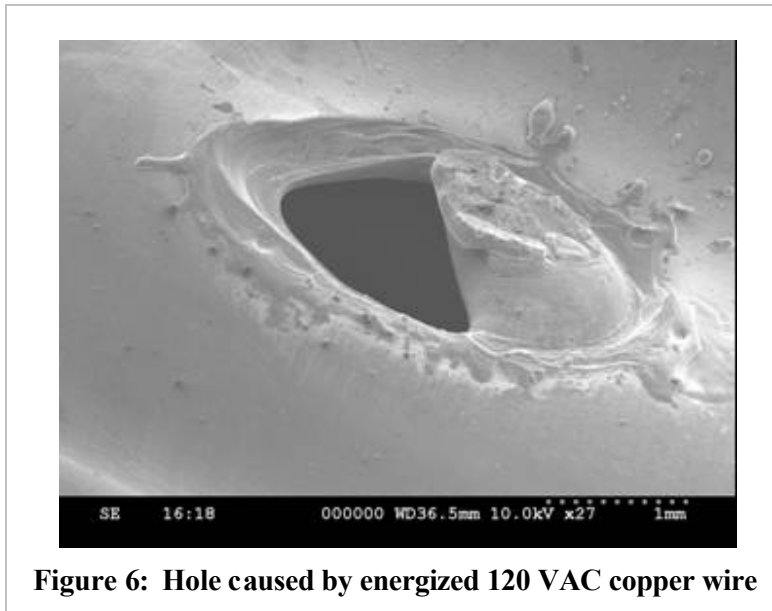
Investigation of a fire caused by CSST and lightning is a straight forward process. One of the characteristics of CSST that makes this a simple investigation is the high melting point. Stainless steel is not prone to melt during a fire. If a hole is found in CSST, there is a good chance that the hole is from electrical current. One would need to reasonably eliminate other sources of the leak, to include eutectic melting (alloying) and mechanical damage. Microscopic work would be necessary to insure that the orifice was created by an arcing condition. As with copper wire, one is looking for sharp delineations between fused and non-fused areas. If there appear to be other metals present at the arc site, one should conduct EDX (Energy Dispersive XRay) to see if the metal being examined is stainless, or if it has other metals present (such as Cu, Zn, Al, Sn). If copper is present, one might reasonably attribute the problem to an ongoing fire attacking both the CSST and nearby NM electrical wiring – when the NM faulted to the CSST, a perforation was created. Figure 6 shows a photo taken under a scanning electron microscope (SEM) of a section of CSST that failed when touched by an energized 120 VAC copper wire.

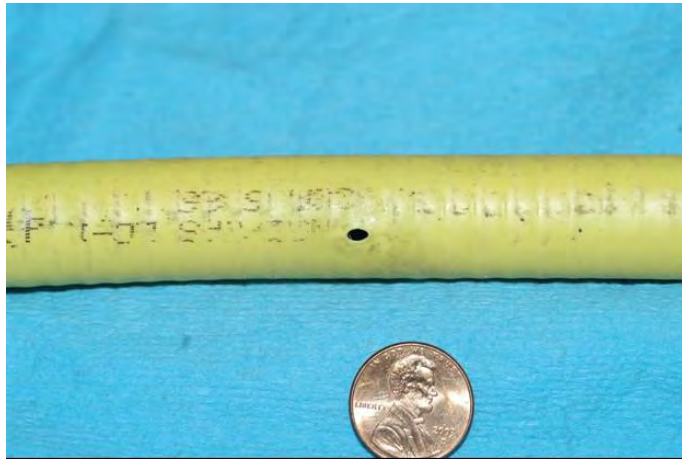
To find holes, we recommend an instrumented leak test at ~7" WC air. One end of the CSST should be plugged, and each hole sequentially plugged (modeling clay seems to work the best) until the CSST no longer leaks. One of the holes we found in CSST was in an area of tubing where the polymer coating had no pyrolysis (See Figure 7). Also, Figure 8 is a microscopic view of this small leak. As in any fire investigation, the leaks and subsequent flame development must support the area of origin, or the leaks would appear to be of little consequence.

Figure 7: Photo of perforated CSST without pyrolysis

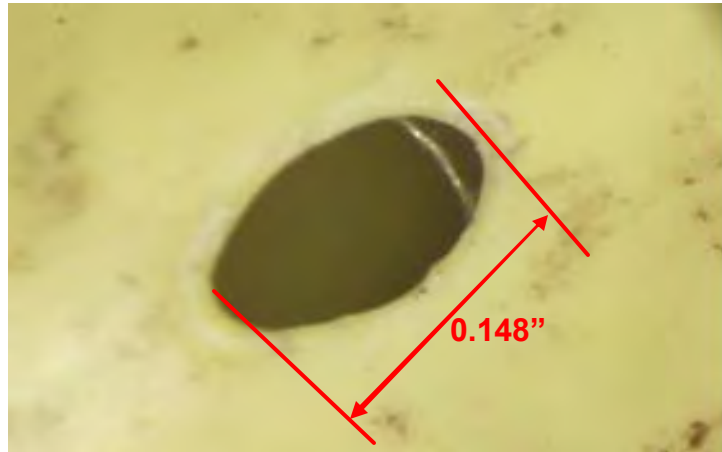
Figure 8: Microscopic View of Perforated CSST

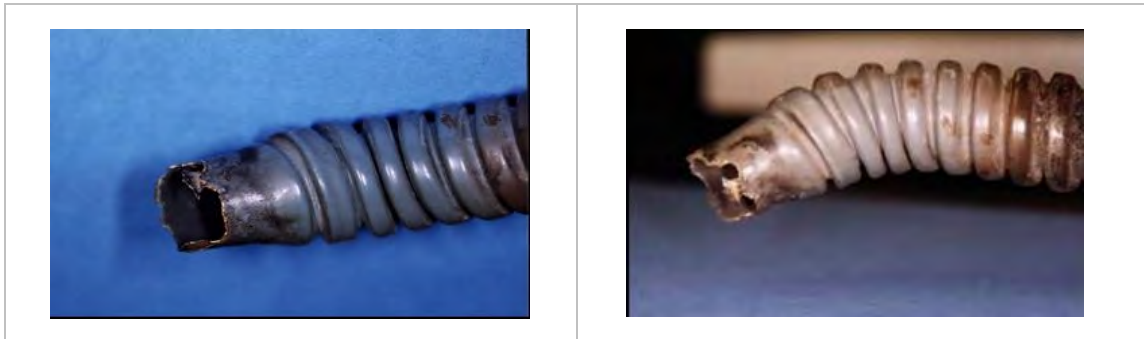
The Frisco Fire Department Report lists escaping gas from the end connectors during lightning events as also being possible sources of ignition²⁶. In a previous article written by one of the authors (MEG), this very phenomenon was described on appliance connectors²⁷. The fact that a gas line fails at a connection is no surprise, in that gas lines are chosen for mechanical integrity at their junctions, and not necessarily electrical conductivity. Figure 9 shows the end of a failed appliance connector that has arced and caused a fire due to electrical current flow. We might expect to see similar manifestations with CSST at its connectors.

Figure 9: Bottom and side respective views of failed gas line from appliance connectors
