FIRE AND MATERIALS 2005

LIGHTNING INDUCED CSST FIRES

Mark Goodson PE*
Mark Hergenrether MSME*
Goodson Engineering, USA

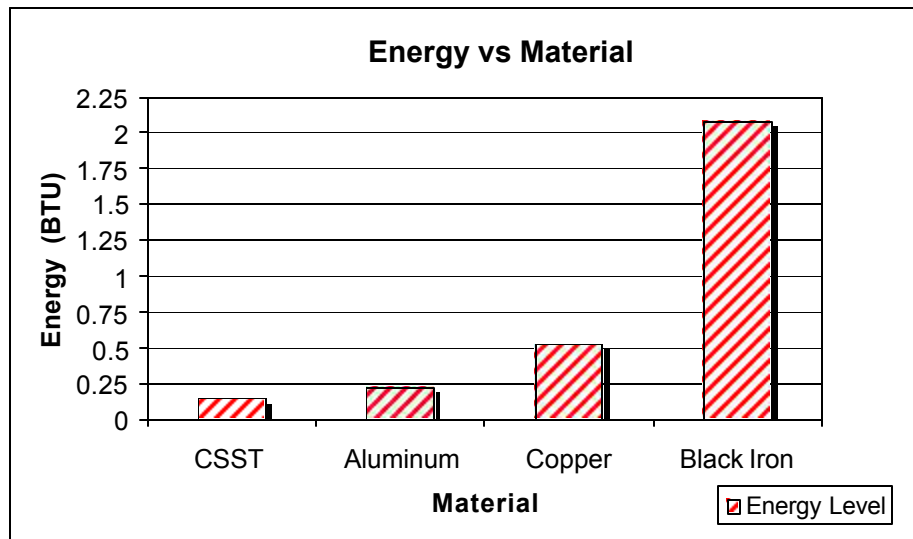
Figure 2 is a plot of the respective values for each material. It is clear from

Figure 2 that the amount of energy to create a 100 mil diameter hole is much larger for black iron pipe than for any of the other three specimens. Thus we can now see why the thickness of the pipe plays such a critical role. In fact for this particular case, the amount of energy for a conventional 1/2" black pipe will require ~15 times the energy that would be required to similarly melt CSST, ~10 times the energy for aluminum, and ~5 times the energy for copper.

Figure 2: Comparison of heat capacity for 100 mil diameter hole in CSST, Aluminum Copper & Black Iron
